HITLER'S TANKS

GERMAN PANZERS OF WORLD WAR II

EDITED BY
CHRIS McNAB

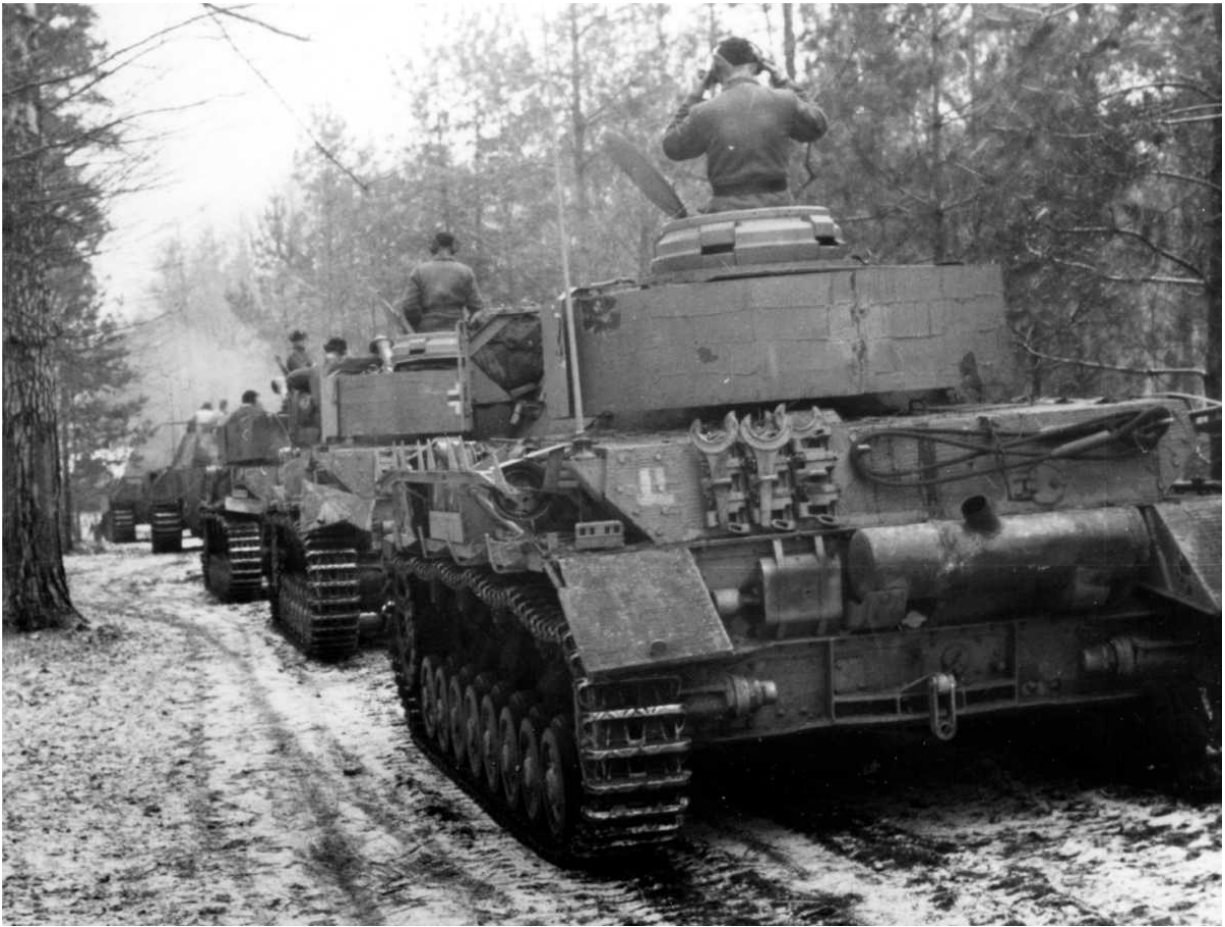
PzKpfw Ausf Hs, serving with the Das Reich Division, advance through the forests of Russia in February 1943. The Ausf H was essentially the same as the late-production Ausf G except for a series of small changes, including a new planetary drive cover and thicker turret-roof armour. (AirSeaLand/Cody)

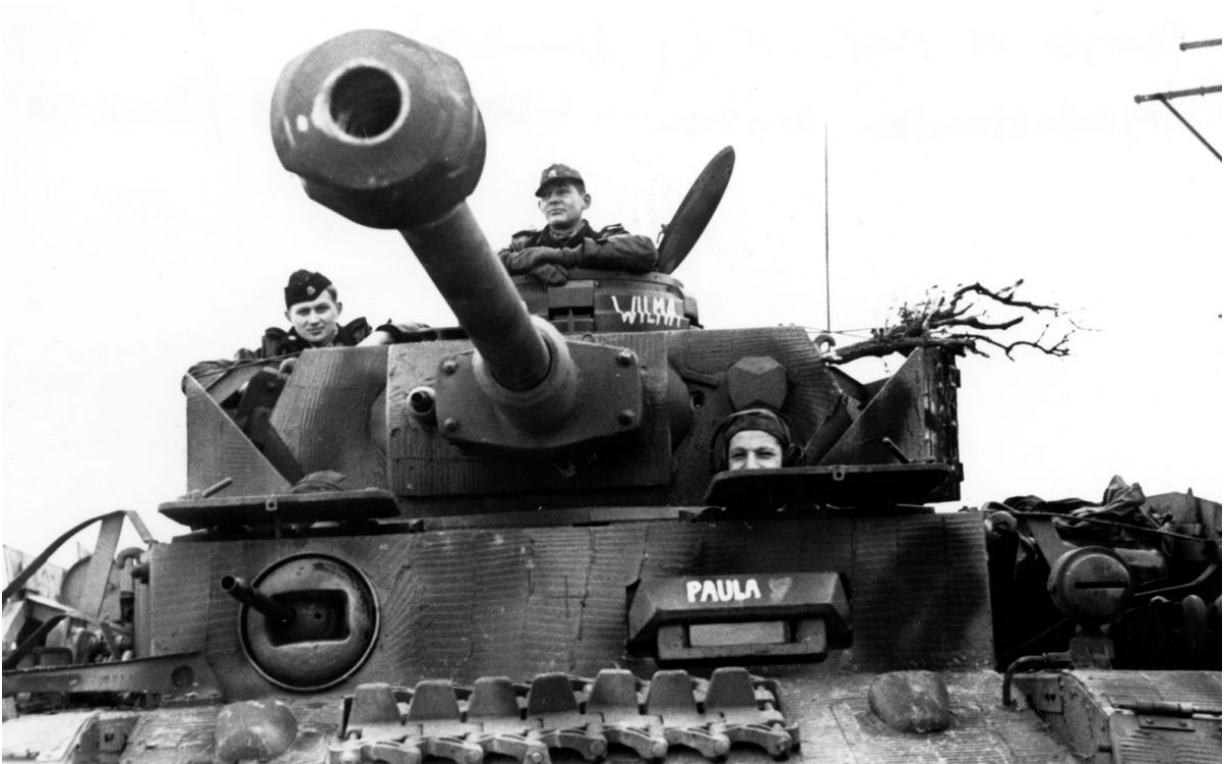
A good close-up of the front hull and turret of the PzKpfw IV Ausf H, this particular one serving with the Hohenstaufen Division in France in 1944. Note the Zimmerit paste applied around the hull machine gun and driver's vision block. (AirSeaLand/Cody)

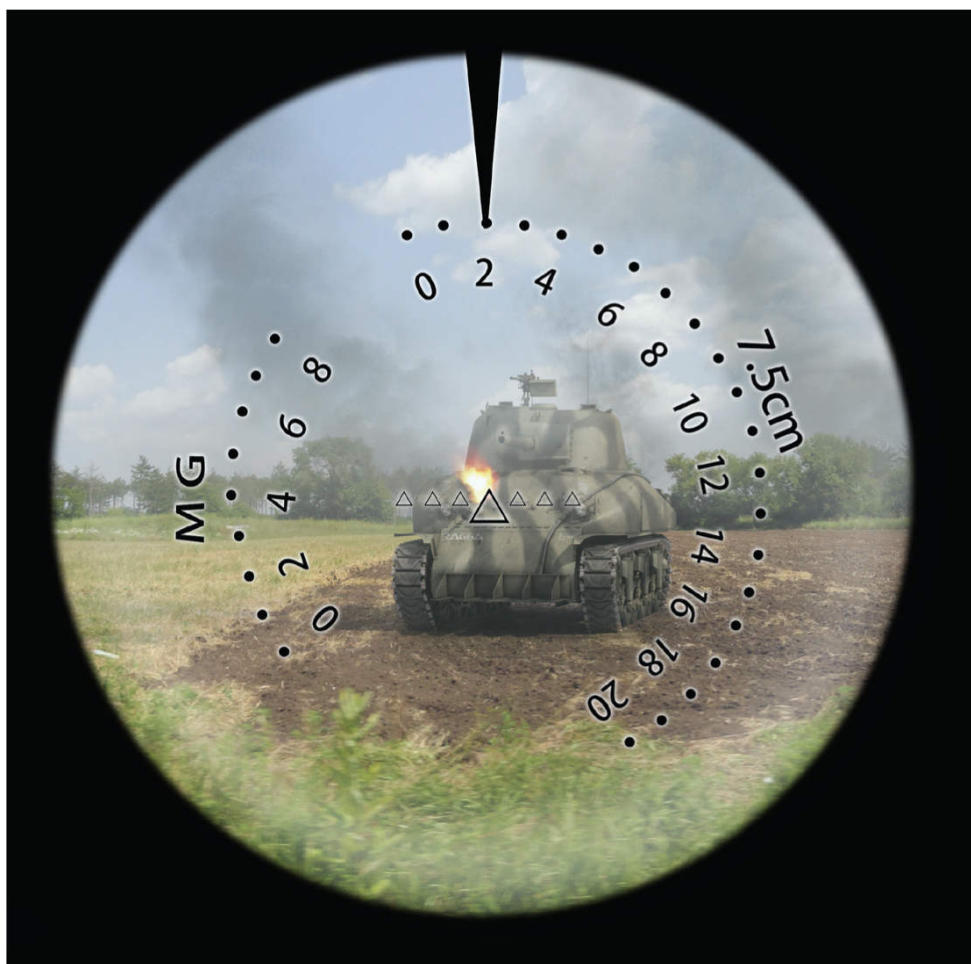
TZF 5B TELESCOPIC GUN SIGHT

The 7.5cm KwK 40 gun on the PzKpfw IV Ausf H was aimed using the Leitz TZF 5b (*Turmzielfernrohr*) monocular telescopic gun sight. This telescope operated at a single magnification of 2.5× with a 25° field of view. The sight contained two engraved reticles. The centre reticle consisted of an aiming triangle in the centre with smaller triangles on either side. The gunner placed the target at the apex of the centre triangle. This reticle provided a limited stadiametric ranging capability which allowed a well-trained gunner to estimate the range based on the size of the target compared to the large triangle. The unit of measure was a graduation (Strich) equalling 1m at 1,000m range, with the larger triangle having sides of four graduations and the smaller triangle having sides of two graduations. Such calculations were too difficult in the heat of battle, so a gunner had to be so well trained that the procedure became instinctive. In actual practice, the gunners often used the co-axial machine gun to determine range. The series of triangles was intended to provide the gunner with a method to gauge the speed of a crossing target. The second reticle provided the graduations visible around the periphery of the reticle and was used to adjust the weapon depending on the weapon and the range. In the case here, the reticle has been turned to the setting for the 7.5cm gun at a range of 200m. The two reticles were mechanically linked and by rotating the reticle, the gunner moved the centre aiming reticle, forcing him to elevate the gun to compensate for range.

The telescopic sight for the long 7.5cm possessed all the same complexity as that discussed in [Chapter 3](#). On the PzKpfw IV, however, the HE scale (Gr34) and the machine-gun scale were common and were marked from 0 to 3,200m, while the two AP scales (Pzgr 39 and Pzgr 40) were marked respectively from 0 to 2,400 and from 0 to 1,400m.

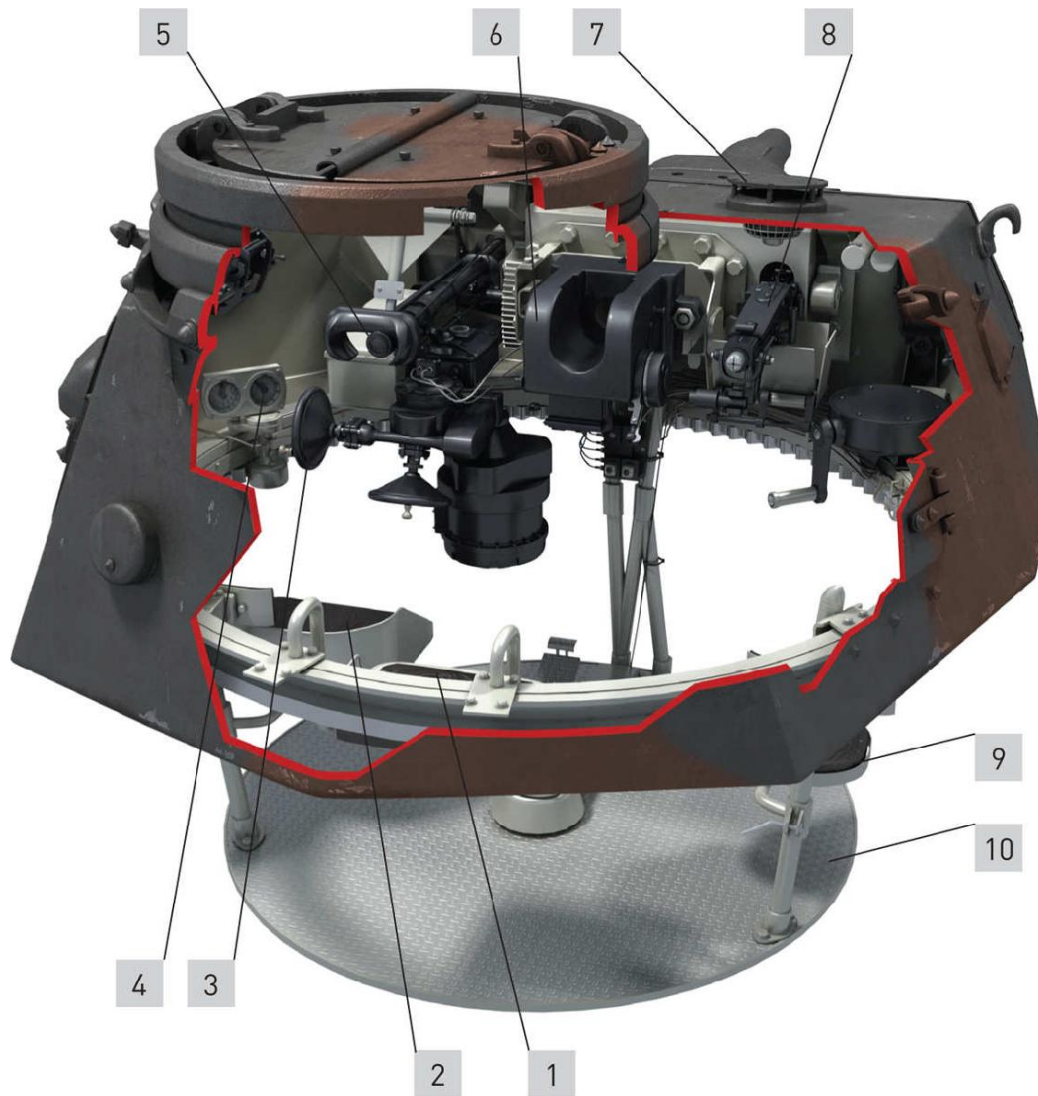
PZKPFW IV TURRET

- 1.** Commander's seat
- 2.** Gunner's seat 5 6 7 8
- 3.** Gunner's elevating and traverse handwheels
- 4.** Gunner's azimuth
- 5.** Gunner's indicator TZF 5b telescopic sight
- 6.** 75mm KwK 37
- 7.** Turret ventilator

The PzKpfw IV crew consisted of five men: three in the turret and two in the hull. The PzKpfw IV had a turret basket with rotating floor. The tank commander (*Kommandant*) sat on 'the throne' in the rear centre of the turret behind the main gun. Above the throne was an armoured cupola with vision ports that were shielded externally by armoured visors and 50mm-thick bullet-resistant glass. In addition, the cupola had an overhead hatch that allowed the commander to operate with his head out of the tank for better situational awareness. The commander communicated with the crew via a throat microphone and intercom system. The gunner (*Richtkanonier*) was located in the left side of the turret. The main gun was aimed using a TZF 5b telescopic

sight. The gunner could traverse the turret either with a mechanical handwheel or an electric drive powered off an auxiliary motor that could turn the turret 360° in 23 seconds. A British report concluded that, 'the maximum speed [of the electric traverse] is relatively low, but the response is quick and the braking good ... The number of resistance steps is too small with the result that the characteristic is noticeably stepped, making it impossible to follow moving targets accurately particularly at low angular speeds.' The hand-gear required 190 turns for a complete rotation of the turret. The loader (*Ladekanonier*) had a seat on the right side of the turret but in action the seat would be folded and the loader would stand on the turret basket floor. The ammunition was distributed around the PzKpfw IV's interior in several bins scattered around the fighting compartment; those in the driver's compartment were accessed with the assistance of the radio operator. The loader was also responsible for loading the co-axial machine gun, which was directly in front of him. The driver (*Fahrer*) was located in the left front of the hull. Steering was a conventional Wilson clutch-steering type manufactured by Krupp, with the transmission in the front centre of the hull and the steering brakes forward of the driver. The driver had a direct-vision port with armoured cover immediately in front of him protected by thick glass; he lacked the binocular telescope found in earlier versions of the PzKpfw IV. The radio operator (*Funker*) sat in the right front hull opposite the driver. The FuG 5 radio transmitter-receiver was mounted centrally above the transmission to the left of the radio-operator. This was a voice/telegraphic AM radio with two preset channels and an effective range of about 2km in voice mode. It suffered from the inherent shortcomings of AM radios in tanks, namely the susceptibility to static noise which made the set useless during travel. It was also less powerful than US tank radios, with only 10 watts of forward power versus 30 watts.

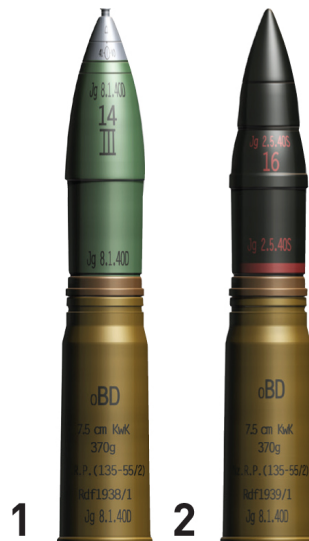
PZKPFW IV AMMUNITION

1. 7.5cm High-Explosive 43
2. 7.5cm Armour-Piercing (Capped)

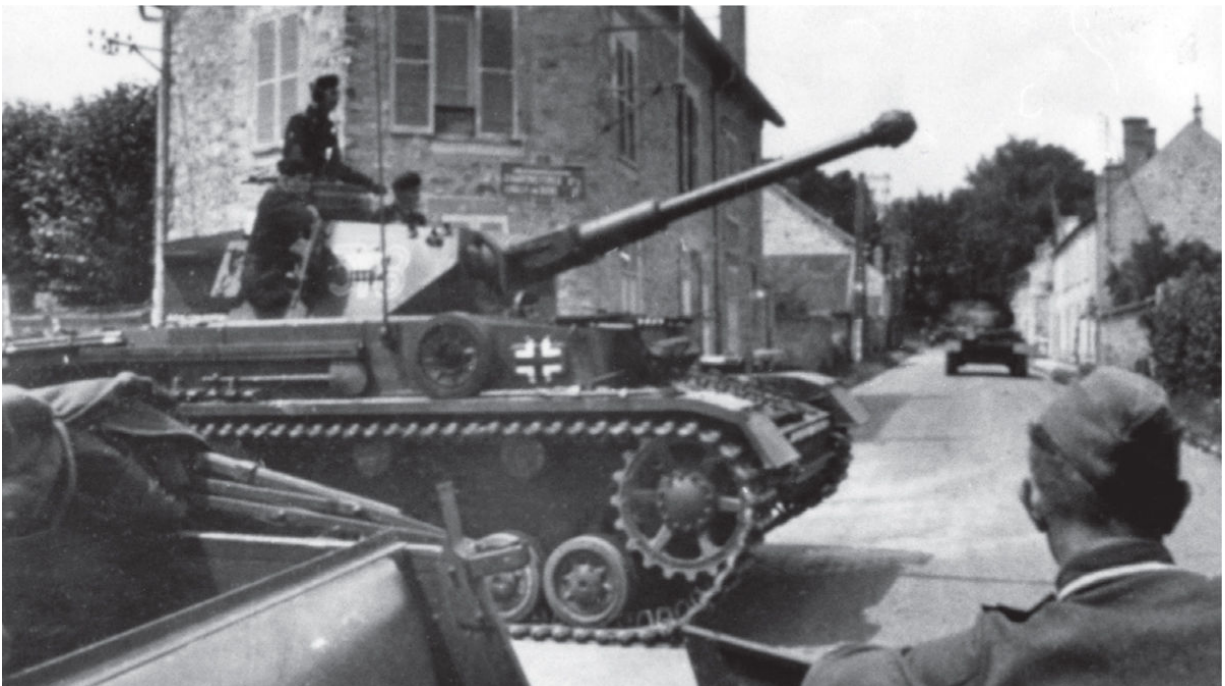
A PzKpfw IV rolls through a town in France in July 1942. Note the spare road wheel stored on the side of the hull; sometimes two or three such wheels might be carried here, on each side. (AirSeaLand/Cody)

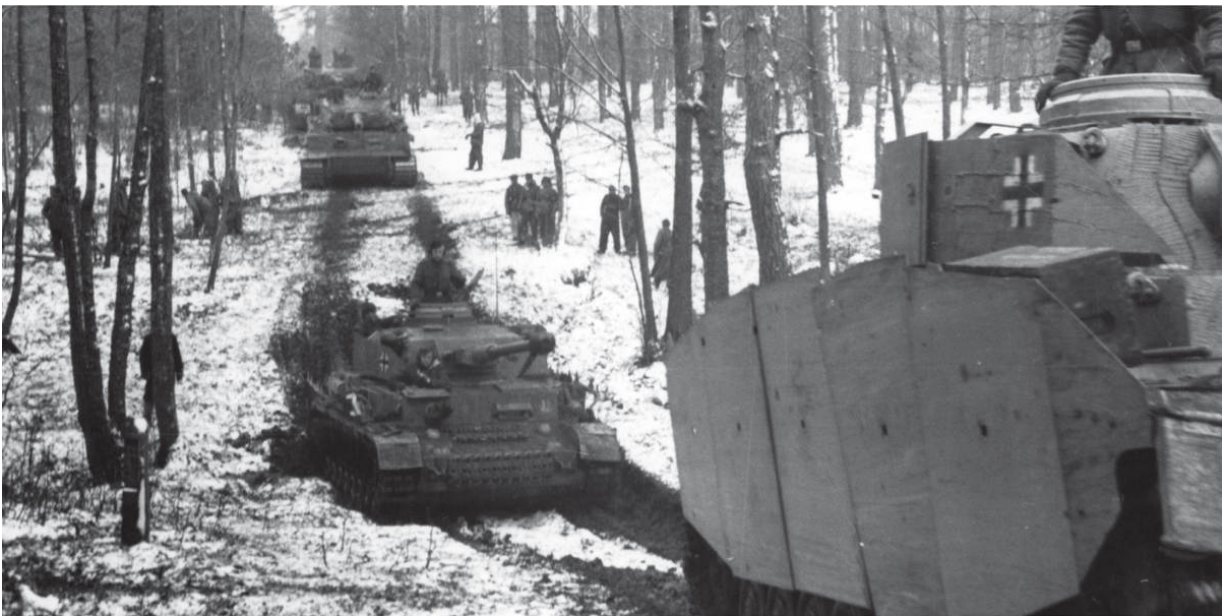
PzKpfw IVs grind their way through a muddy forest. The auxiliary side armour was particularly important in such close terrain, as it provided improved protection against short-range infantry anti-tank weapons. (AirSeaLand/Cody)

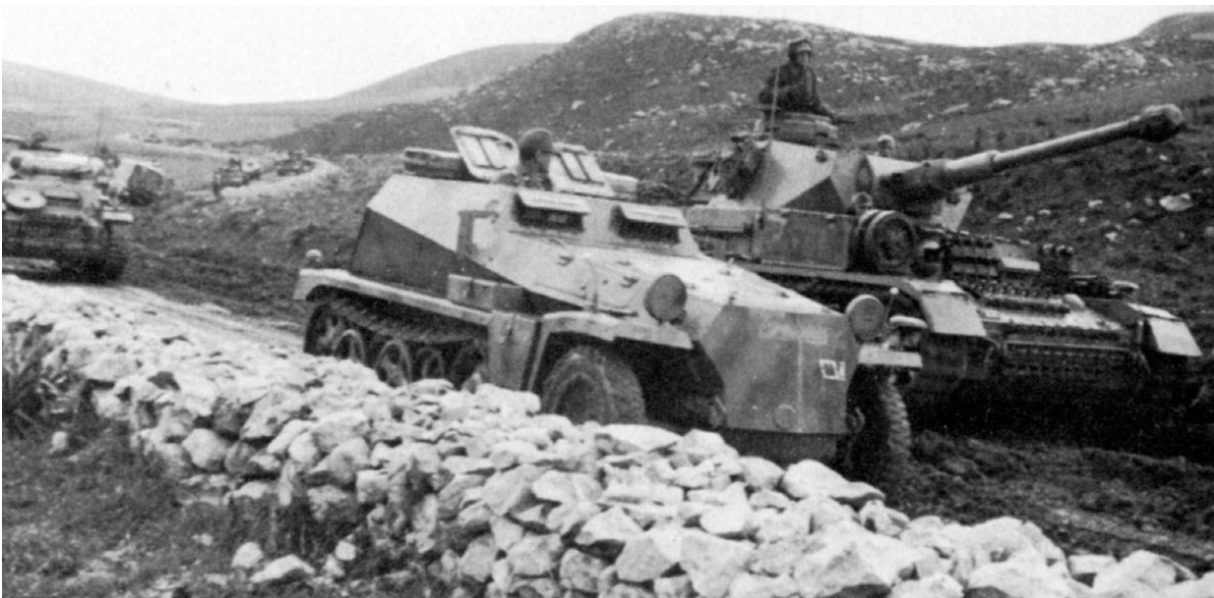
A SdKfz 252 half-track passes a PzKpfw IV Ausf F2 in Tunisia, 1942/43. The PzKpfw IV Ausf F2, later designated as Ausf G, used a ball-shaped muzzle brake on its L/43 main gun.
(AirSeaLand/Cody)

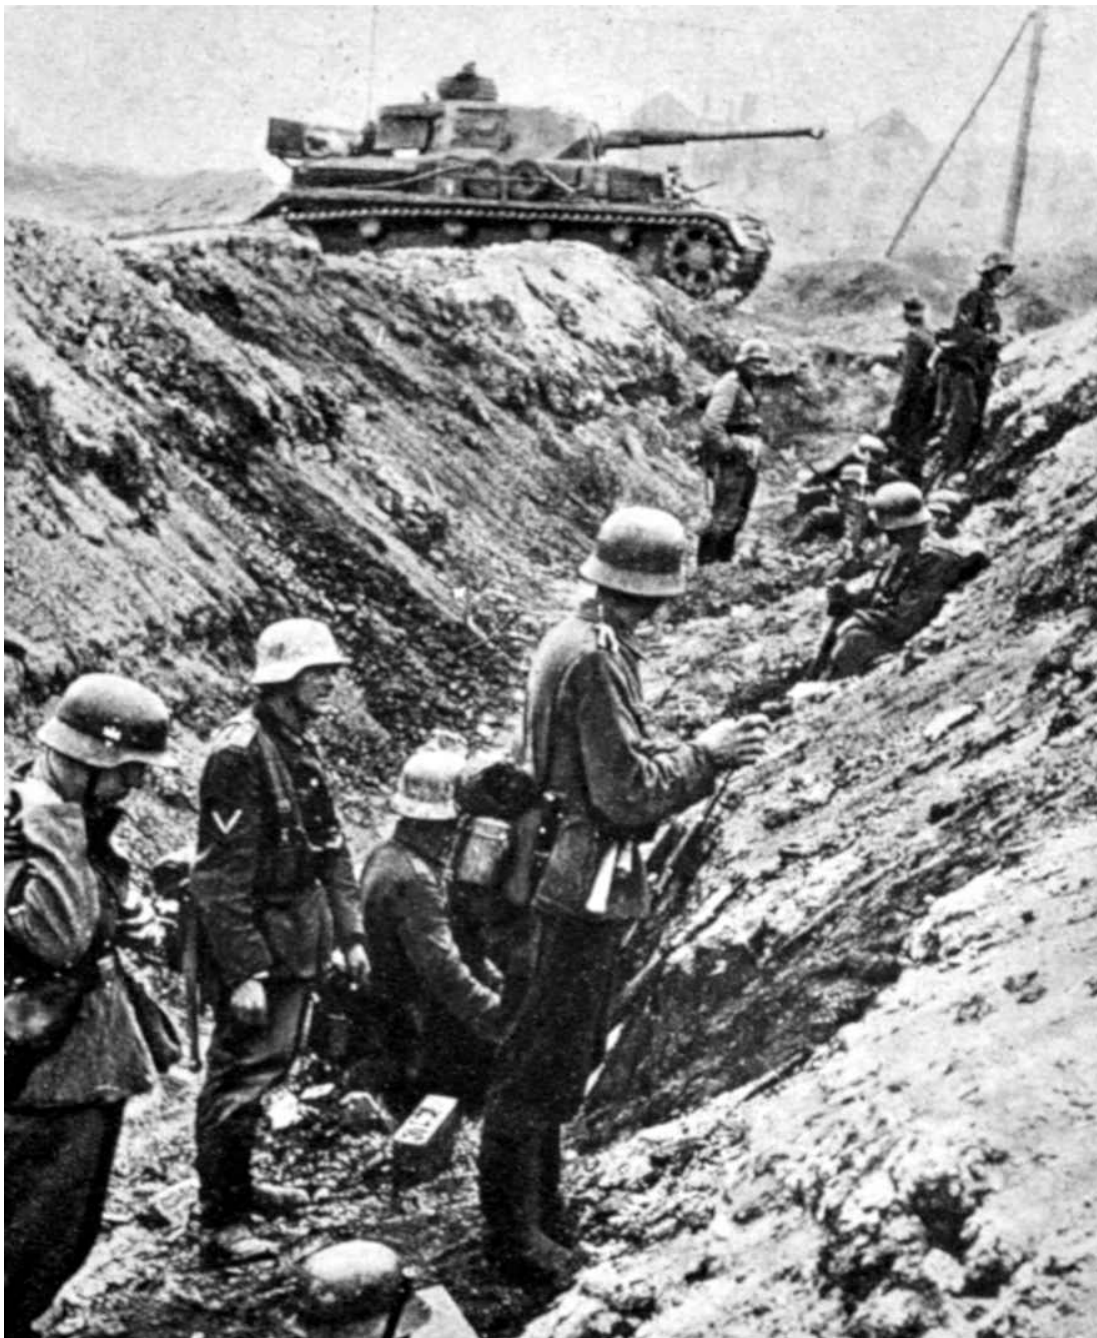
A late-model PzKpfw IV rumbles past German troops in an anti-tank ditch around Stalingrad in late 1942. In June 1942 an extended radio antenna deflector was fitted on the 7.5cm KwK 40 L/43 PzKpfw IV Ausf G but this was dropped again in July 1942. (AirSeaLand/Cody)

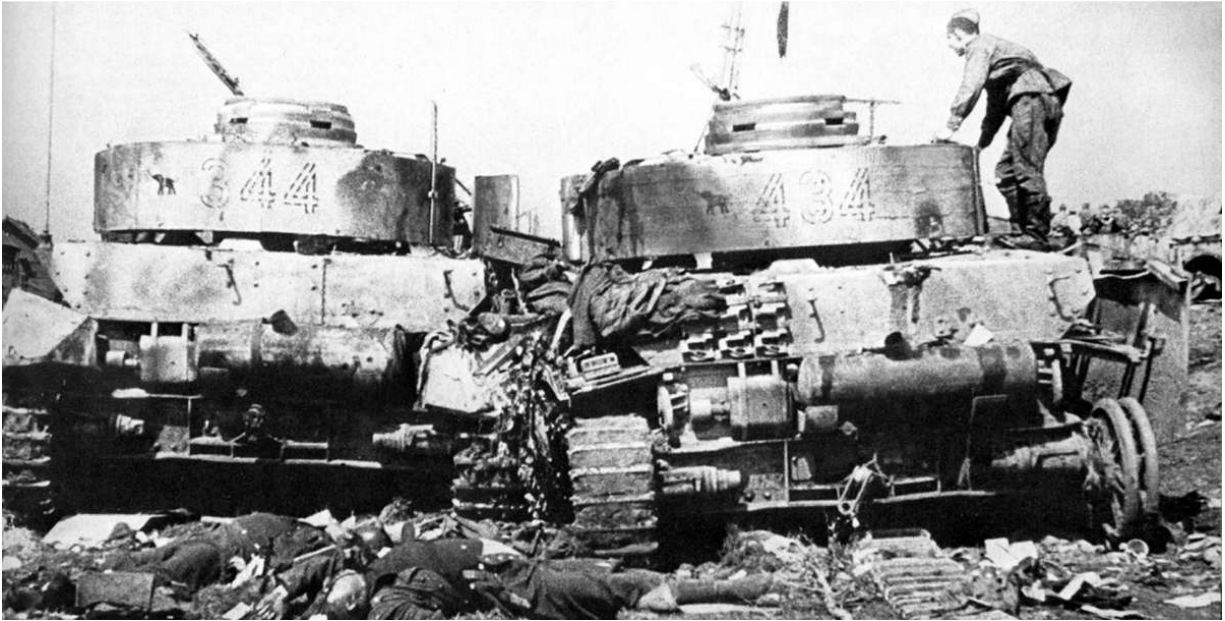
A Soviet soldier cautiously inspects two PzKpfw IV tanks destroyed in fighting in the Bobruysk pocket in late June 1944. Both tanks are fitted with the 5mm Schürzen armour around the rear turret. (AirSeaLand/Cody)

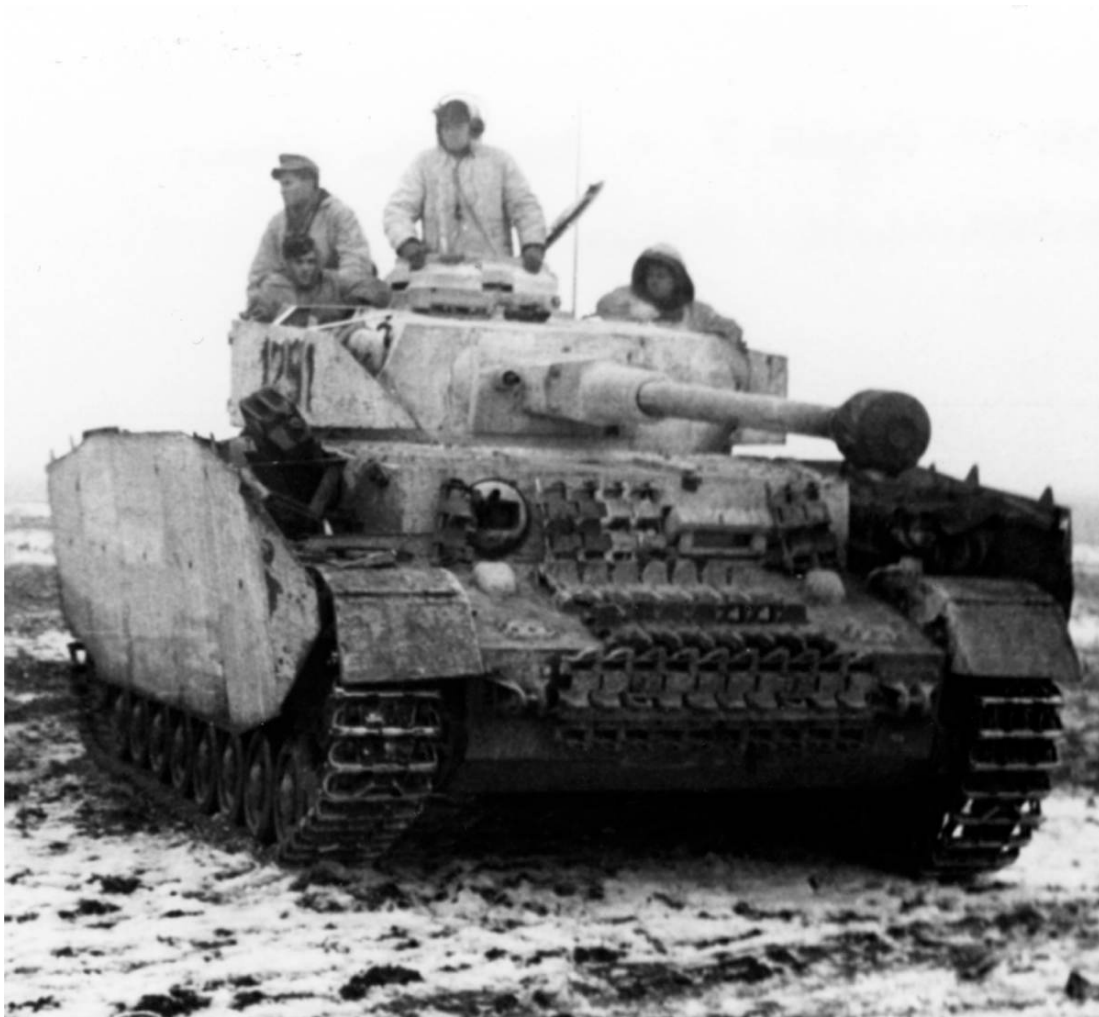
A PzKpfw IV Ausf J of the Leibstandarte Division on the Eastern Front. The interlocking side and front hull plates were characteristic of the Ausf J, but were introduced with some of the final Ausf H. (AirSeaLand/Cody)

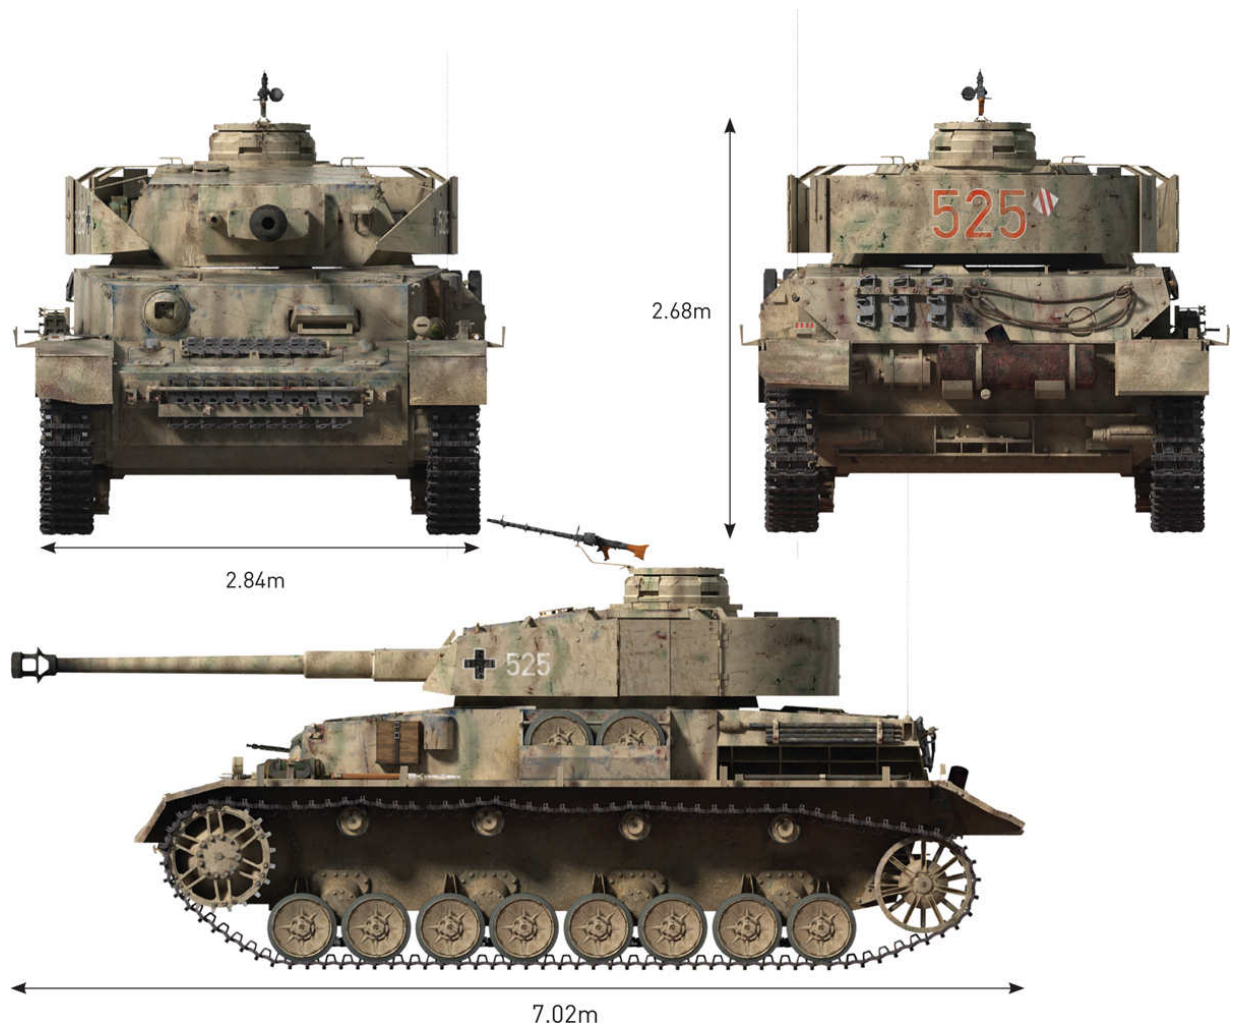
PZKPFW IV AUSF H, 5./PANZER- LEHR-REGIMENT 130, JULY 1944

Top speed: 38km/h

Armour: 50mm gun mantlet, 80mm hull front, 30mm side, 30mm
turret rear

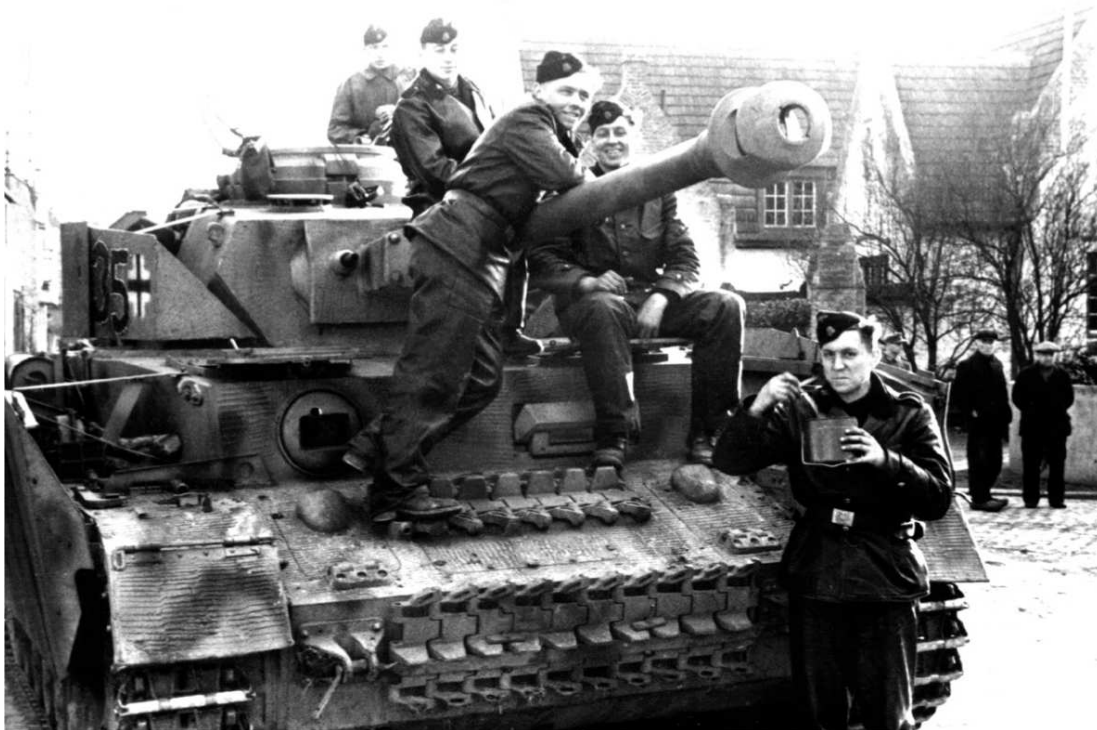
Tank crew members of the Hohenstaufen Division pose for a photo op on their PzKpfw IV Ausf J. The Ausf J dropped the auxiliary turret-traverse generator motor in favour of additional fuel stowage. Turret traverse at this point was manual, using a new two-speed hand-crank supplemented with an auxiliary crank in the loader's station. (AirSeaLand/Cody)

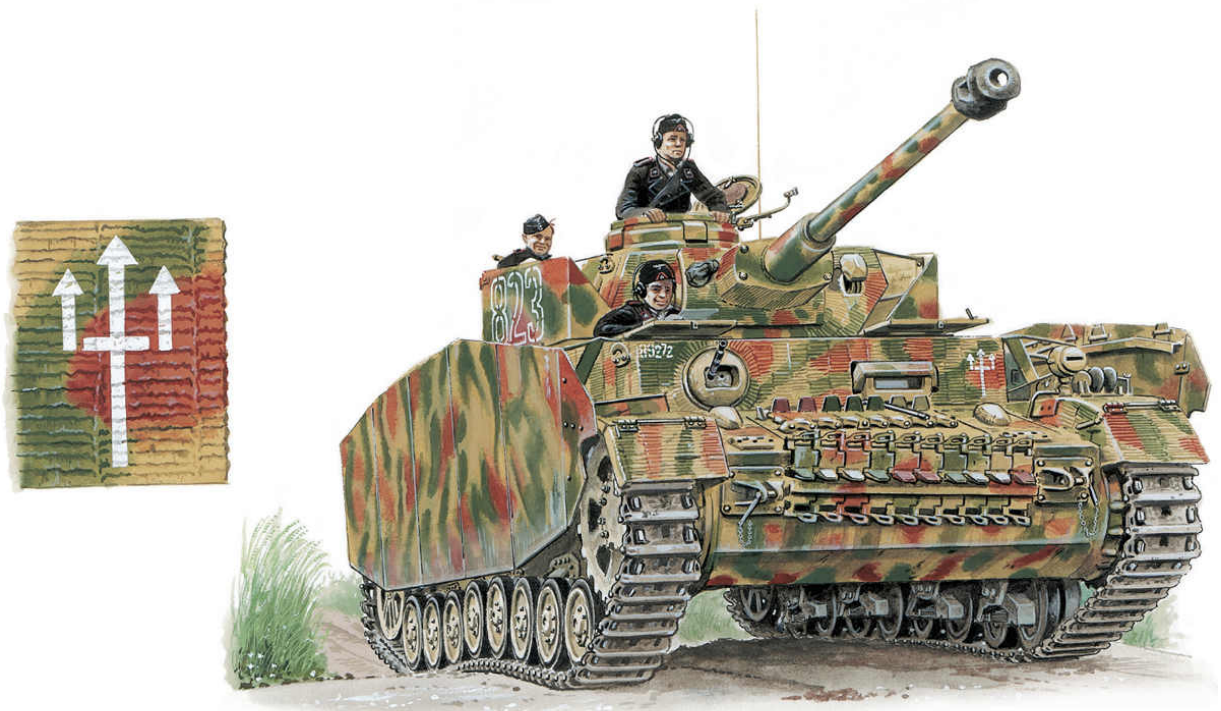
1) PzKpfw IV Ausf J, Panzer-Regiment 3, 2. Panzer-Division; France, early 1944.

Photographed in Picardy in the early months of 1944, this tank is in a dense, dark-toned camouflage of the standard colours, applied in short, mainly diagonal streaks and blotches.

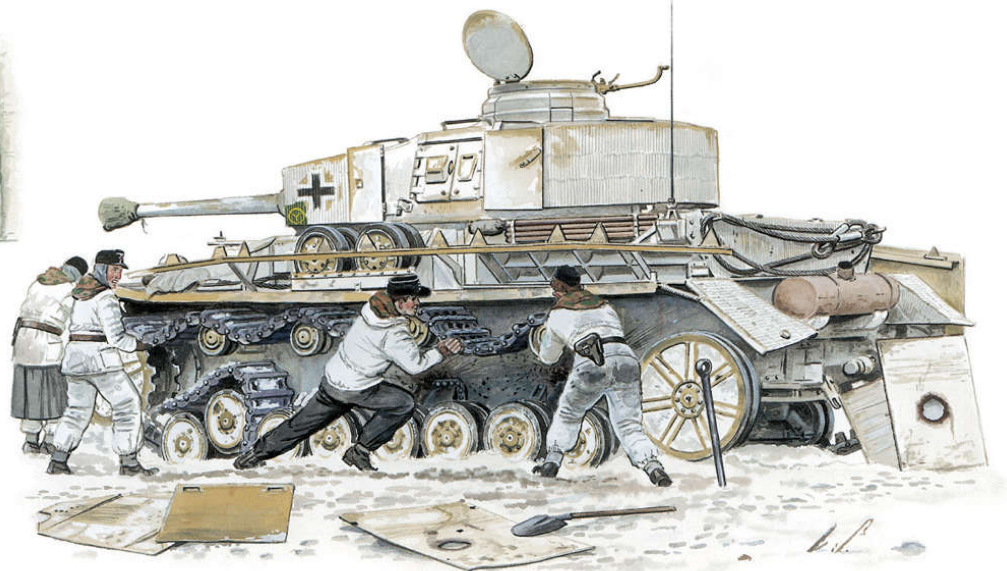
2) PzKpfw IV Ausf J, Panzer-Regiment 29, 12. Panzer-Division; North Russia, early 1944.

This division distinguished itself in the fighting before Leningrad in February 1944. The tank has an overall coat of whitewash snow camouflage over its dark yellow factory scheme; the rough square of dark green left exposed as backing for the divisional sign, at the lower front corner of the turret girdle plate, suggests that it was in multi-colour temperate zone camouflage before being whitewashed. (David E. Smith © Osprey Publishing)

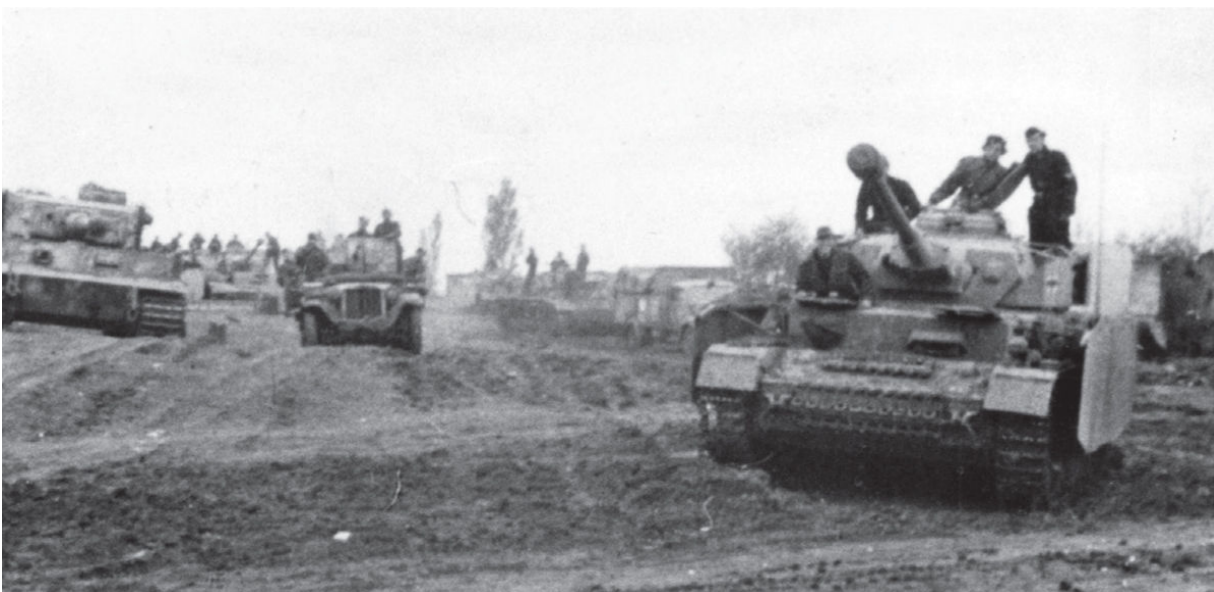
On the Eastern Front in 1943, we here see Panzers of the Das Reich Division. On the right is a PzKpfw IV, replete with Schürzen armour over both the hull and the turret, while on the left is a Tiger I. (AirSeaLand/Cody)

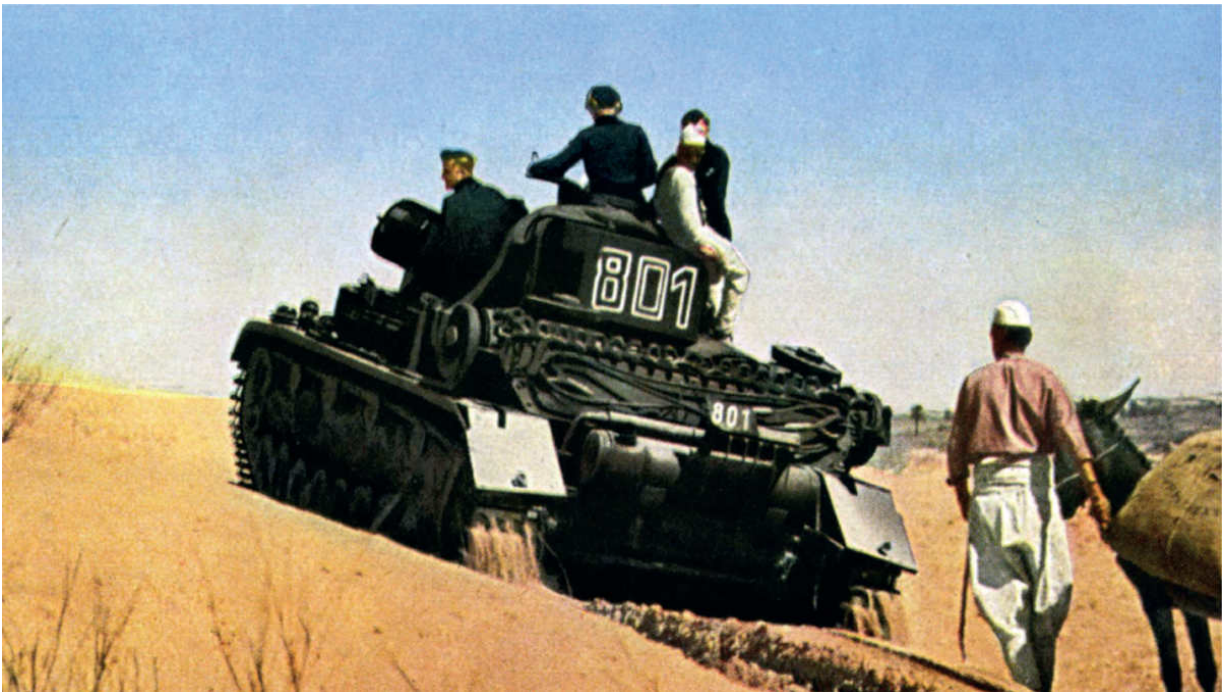
In this evocative image, a PzKpfw IV grinds its way through deep sand in the North African theatre. When mixed with engine oil, the fine particles of dust and sand produced a grinding paste that wore away mechanical components. (AirSeaLand/Cody)

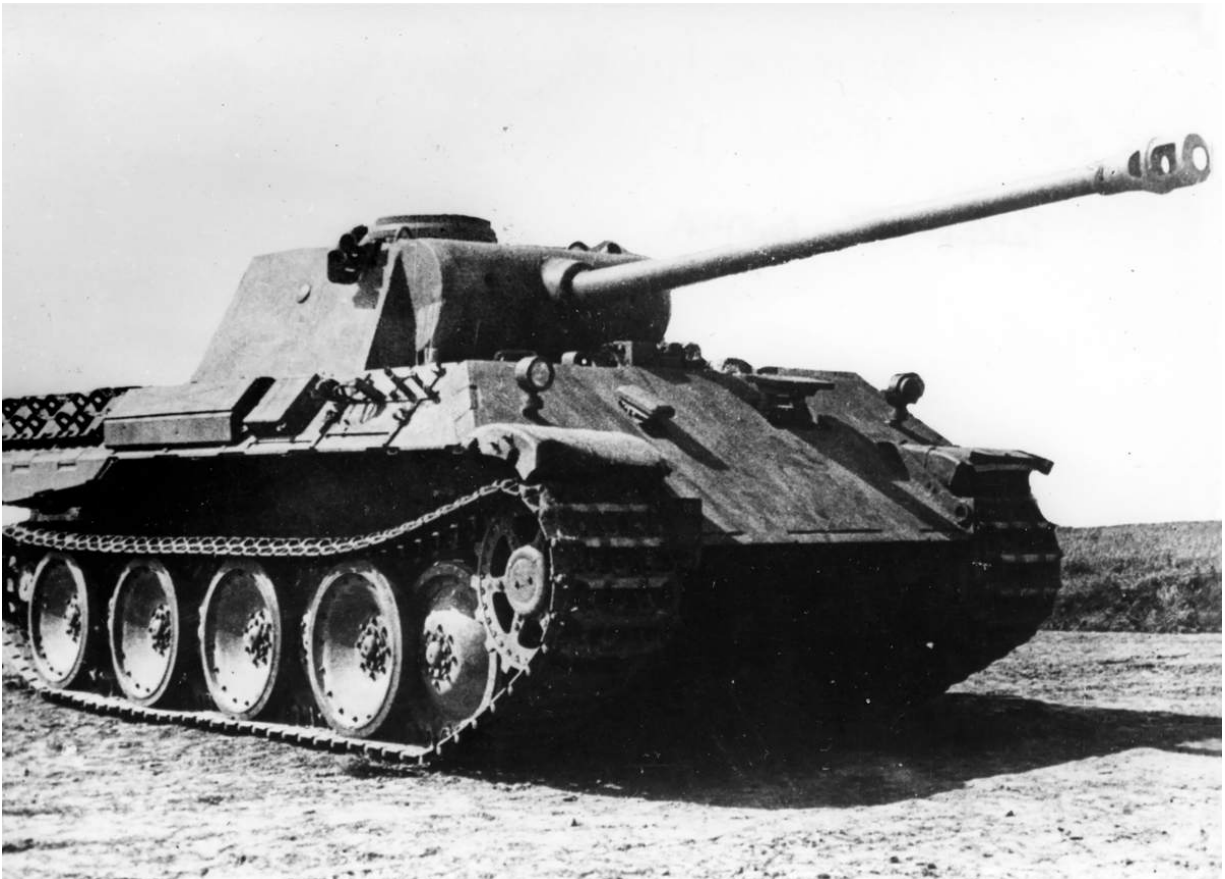
A PzKpfw V Panther Ausf D. Production of this model began in August 1943 and ended the following September. (AirSeaLand/Cody)

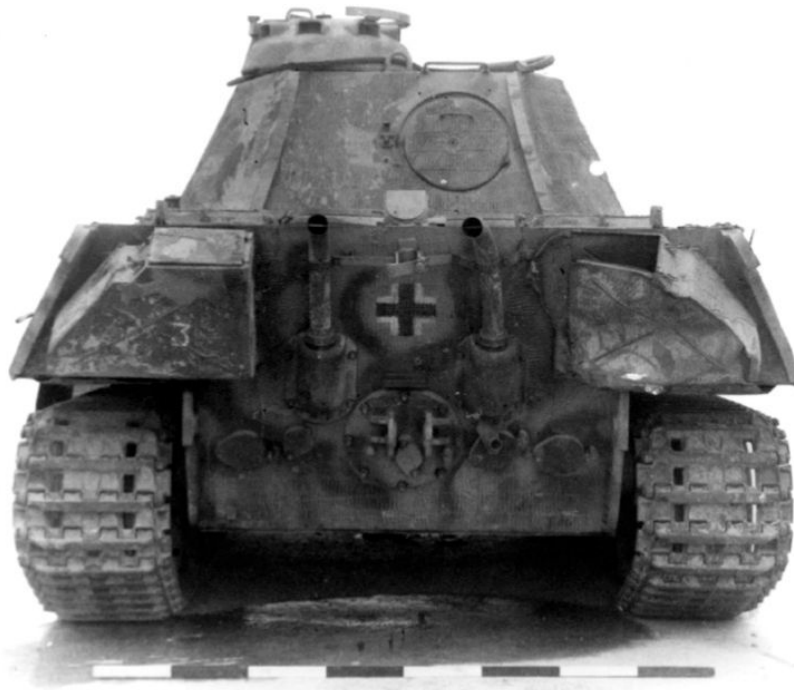
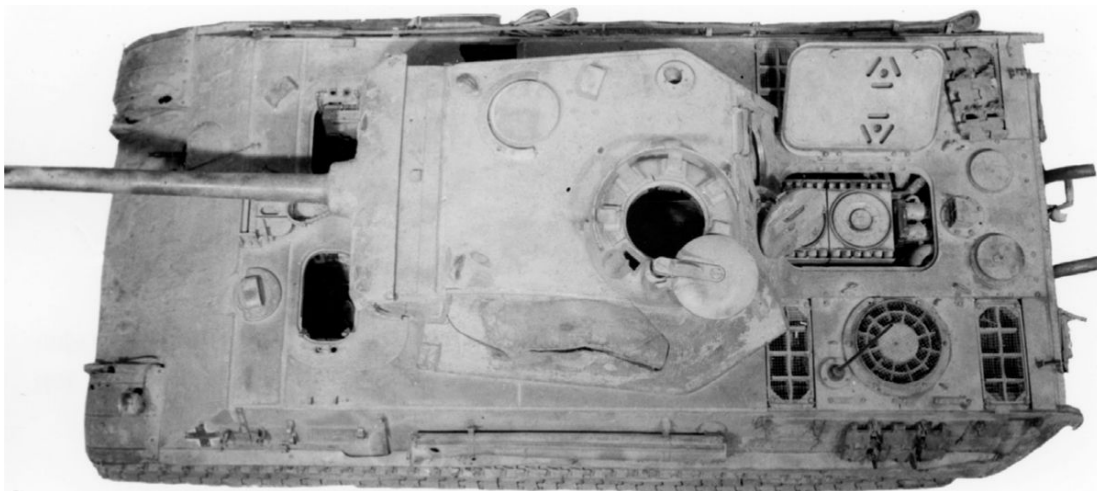
Technical manual illustrations for the PzKpfw V Panther. In the rear view, note the two large stowage bins fitted on both sides of the rear plate, a feature common to all Panthers.
(AirSeaLand/Cody)

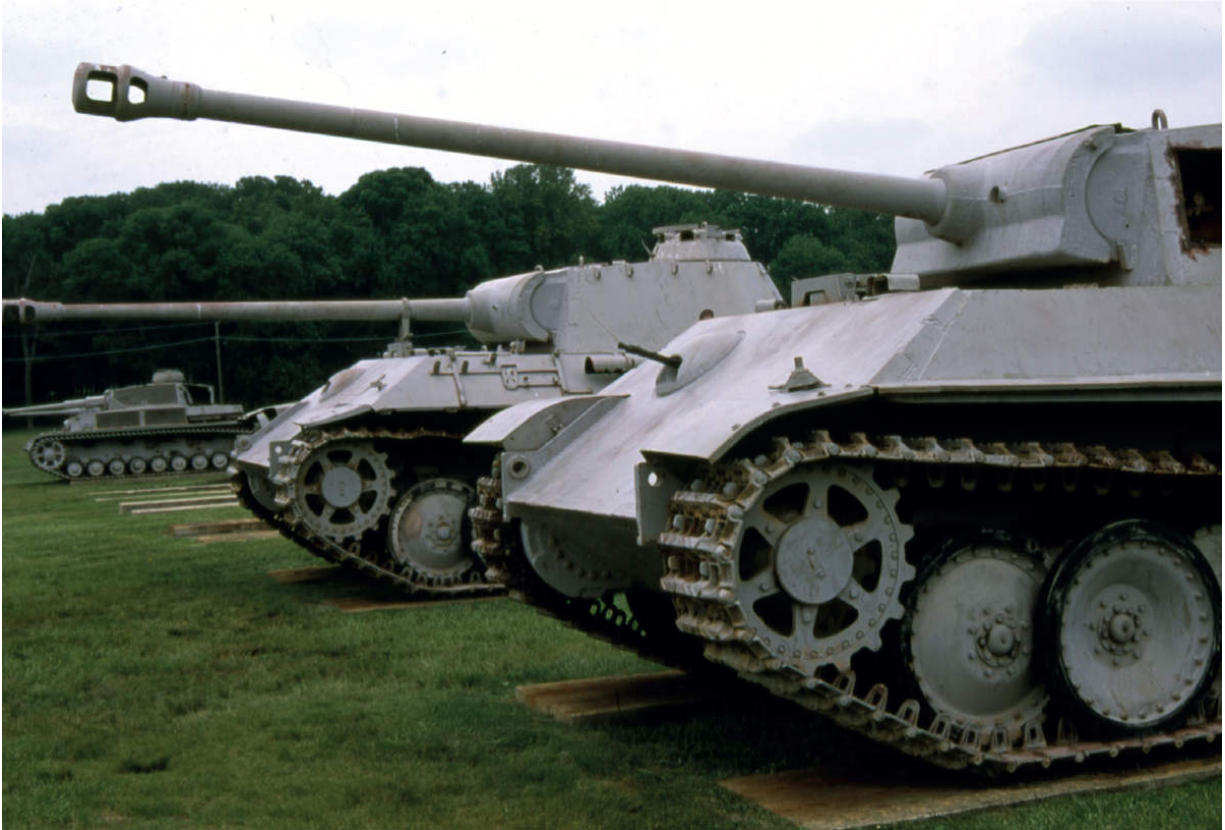
Panthers side-by-side at the Aberdeen Proving Ground, United States. The radio operator also manned the bow machine gun, an MG 34 in a ball mount sighted through a KZF 2 cranked sight. (AirSeaLand/Cody)

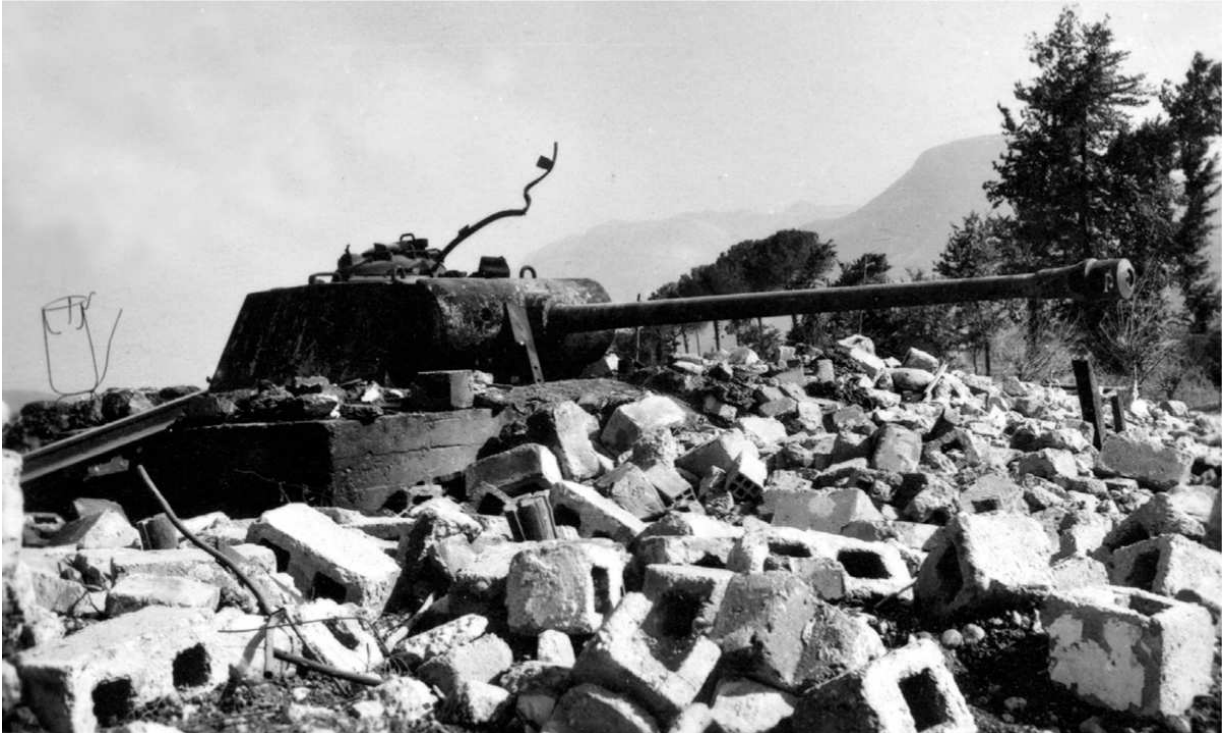
Here, in the mountains of Italy, a Panther turret has been independently mounted on a pillbox to form an improvised strongpoint. Such fittings became common during the last two years of the war. (AirSeaLand/Cody)

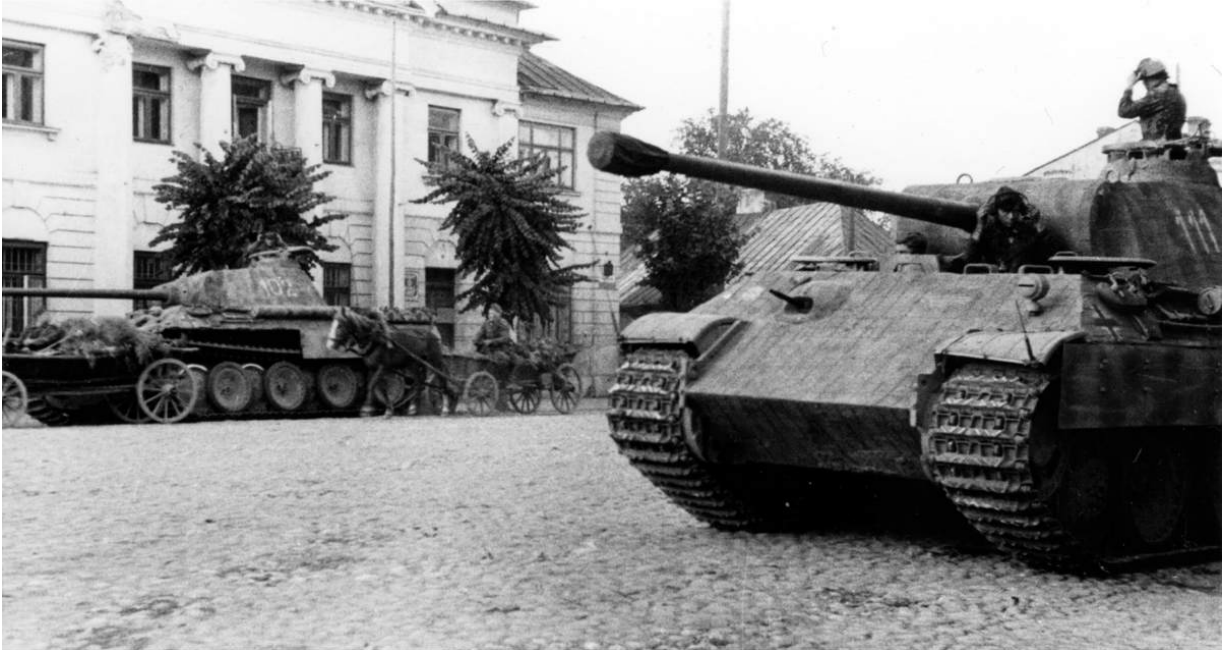
PzKpfw V Panthers make a halt during operations. Note the very smooth sloped front hull of the tank, with no significant 'shot traps' for enemy anti-tank shells. (AirSeaLand/Cody)
